[The invalid 68030 instruction that accidentally allowed the Mac Classic II to successfully boot up](#)

This is the story of how Apple made a mistake in the ROM of the Macintosh Classic II that probably should have prevented it from booting, but instead, miraculously, its Motorola MC68030 CPU accidentally prevented a crash and saved the day by executing an undefined instruction.

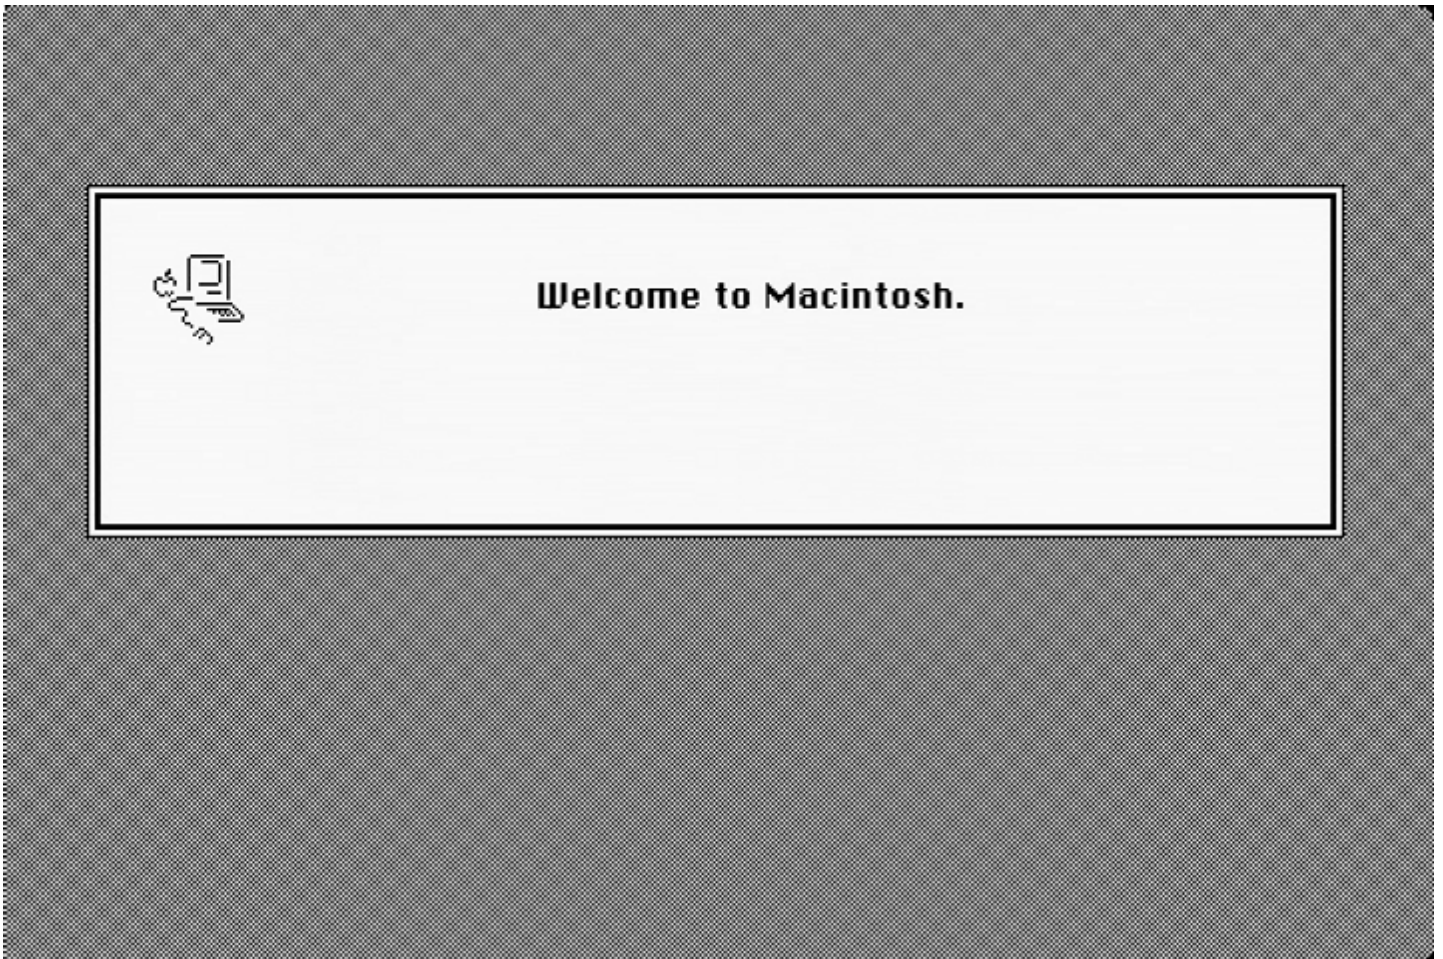
I successfully booted from a SCSI drive using this setup, and could capture the video signal with one of my many video capture devices:

By the way, I think there's something wrong with at least one column of pixels on the left side. I think it has something to do with the tweak I made to the code running on the RP2040 in order to make it sync up correctly with the Classic II's video signal. I'm sure I could fix it if I played around more. The RGBtoHDMI, which arrived a few days later, does not have this problem.

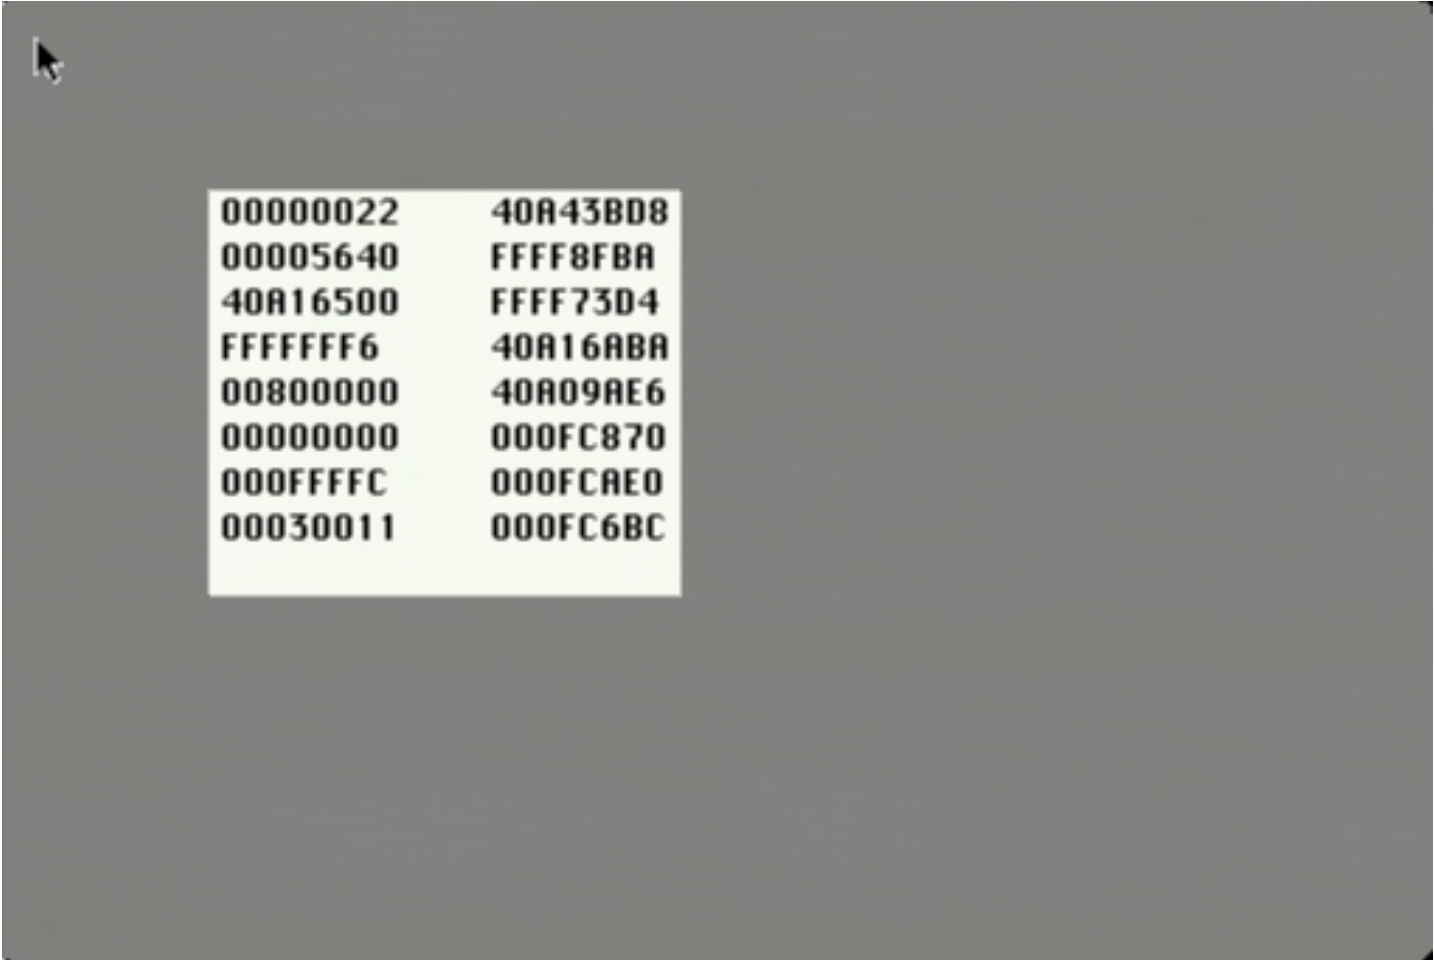
These results motivated me to make a couple more hacked ROM images to run on hardware in order to glean the values of all of the CPU's data and address registers immediately before and after the CAS instruction. The data register values are shown in the left column, address registers in the right column. Before:

00000022	40A43BD8
00005640	FFFF8FBA
40A16500	FFFF73D4
FFFFFFFF6	40A16ABA
00800000	40A09AE6
00000000	000FC870
000FFFC	000FCAE0
00030011	000FC6BC

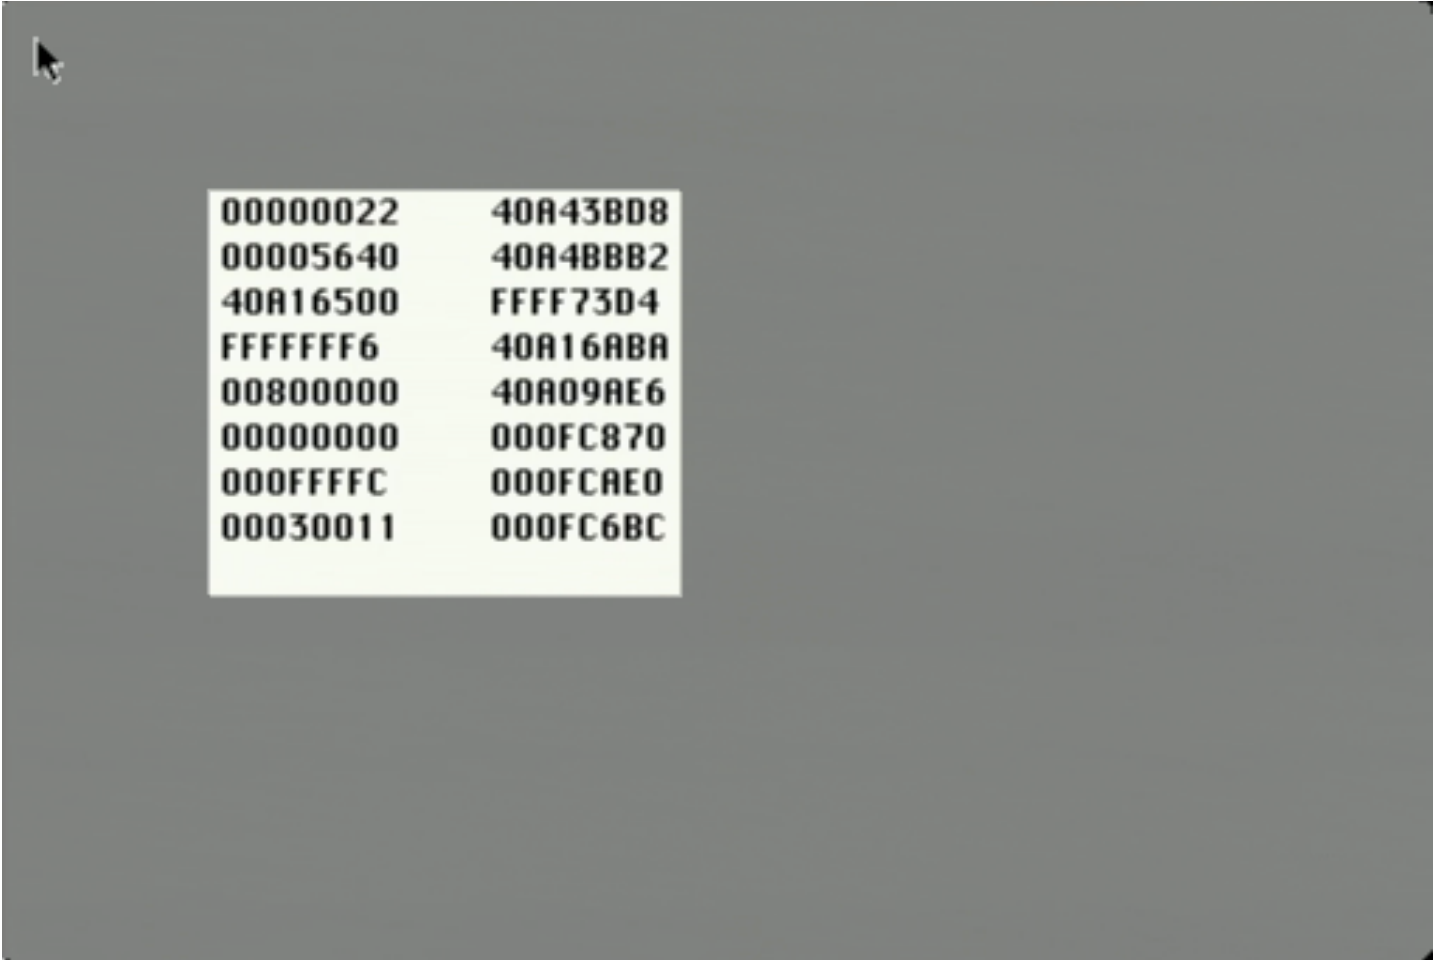
And after:

00000022	40A43BD8
00005640	40A4BBB2
40A16500	FFFF73D4
FFFFFFFF6	40A16ABA
00800000	40A09AE6
00000000	000FC870
000FFFC	000FCAE0
00030011	000FC6BC

Yep! Everything is the same except for A1, which has magically been transformed from FFFF8FBA to 40A4BBB2. The mystery instruction is definitely what was responsible for that.

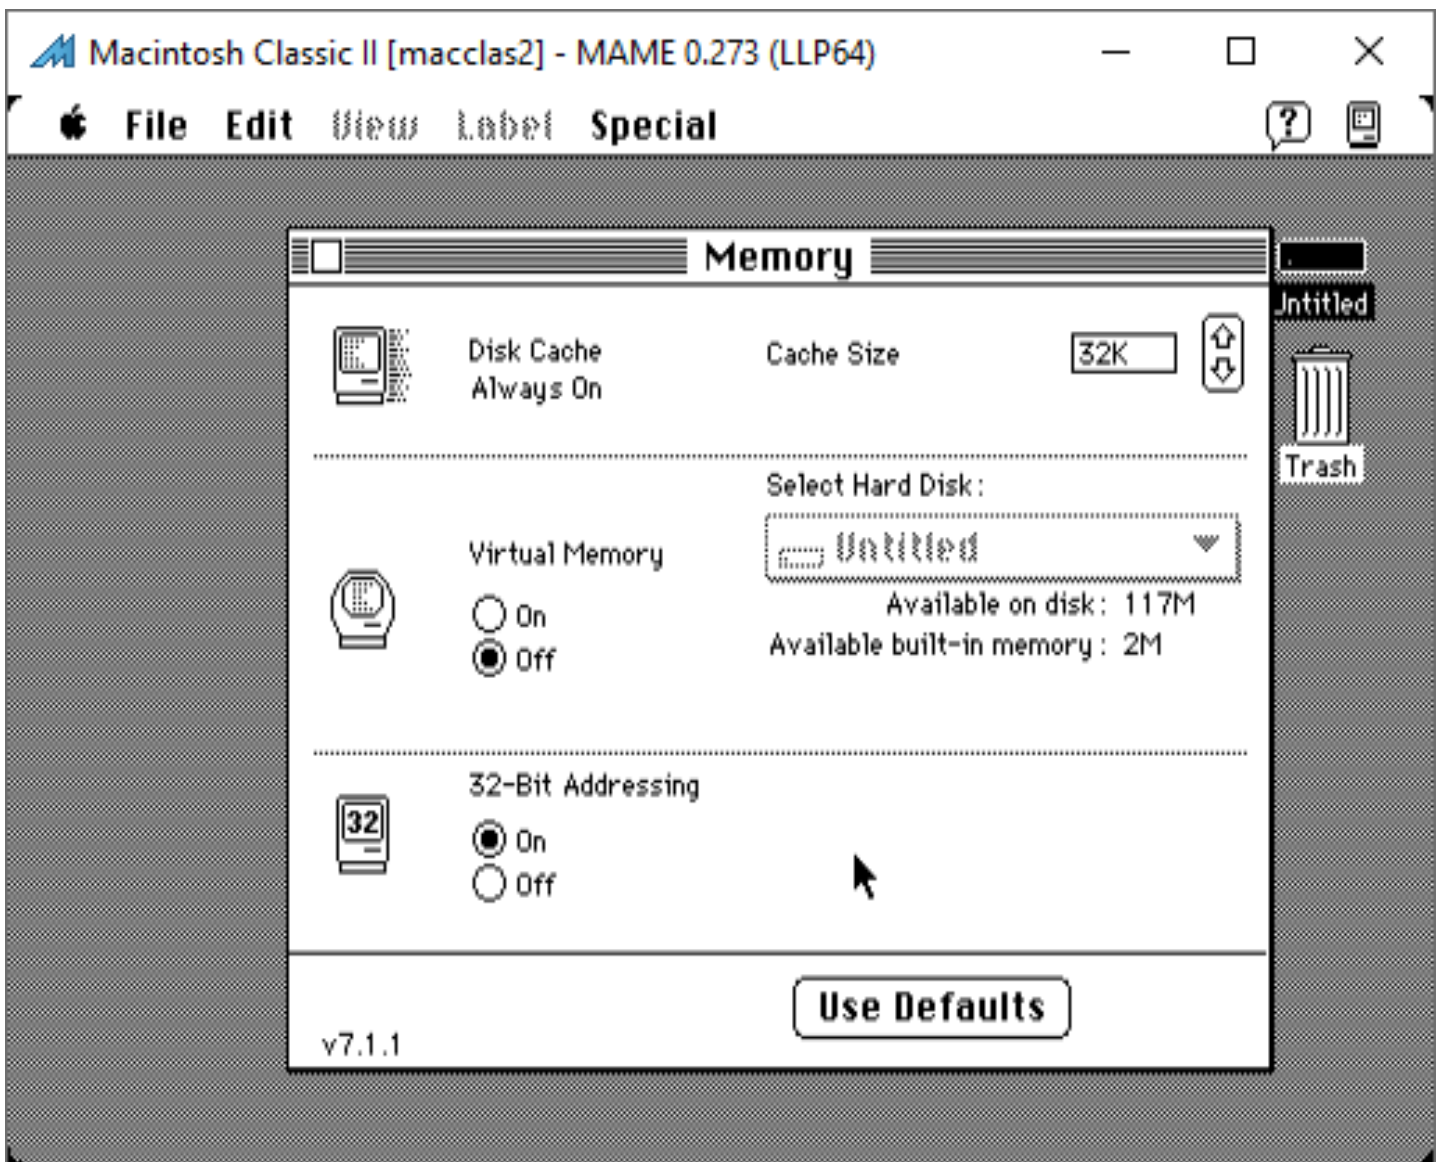
Here's a screenshot of MAME with Arbee's patch applied, now able to successfully emulate a Classic II with 32-bit addressing enabled. Yay!
